Rich Passage Long-Term Beach Monitoring: May to October 2021 Beach Response Report

Kitsap Transit
60 Washington Avenue, Suite 200
Bremerton, WA 98337

Blue Coast Engineering

September 7, 2022

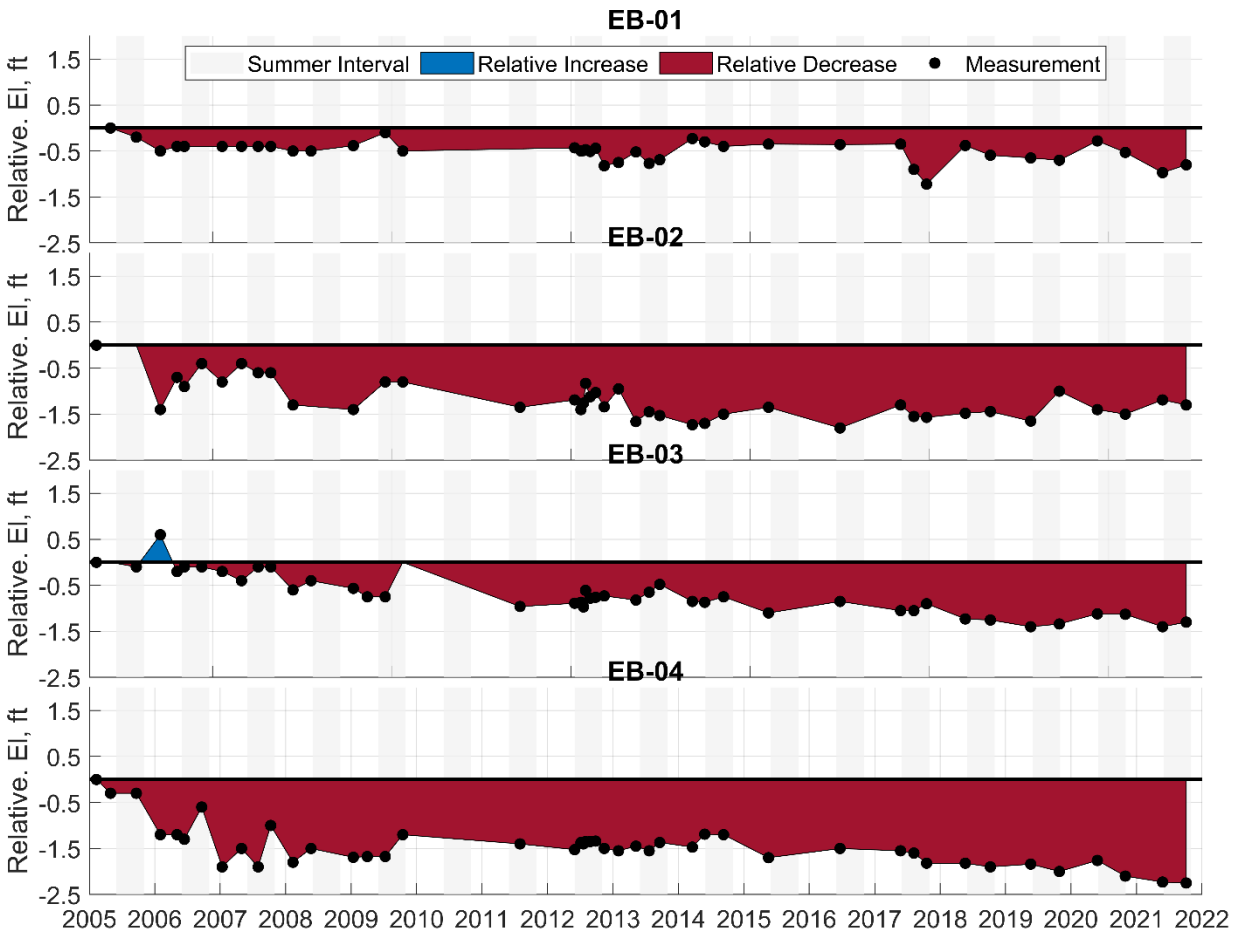
The beaches along East Bremerton tend to be coarse and depleted of sediment on the southern end of the shoreline as observed at sites EB_01 through EB_04 (Figure 3 and Appendix A, Figures A-1 through A-4). The beach elevations at these sites have gradually decreased since 2005 and experience small seasonal fluctuations of +/- 0.25 to +/- 0.5 ft (Golder 2013). Monitoring of beaches along East Bremerton in 2021 showed similar patterns at these sites, with a majority of the sites decreasing in beach elevation year-to-year. Three of the four sites along East Bremerton were lower in October 2021 compared to 2020, only EB_02 increased in elevation (by approximately 0.25 ft). All elevation changes at EB_01 to EB_04 were less than 0.25 feet.

Figure 3. Time series of relative beach elevation from 2005 through 2021 at beach photo survey sites EB_01 to EB_04. Blue indicates accretion relative to the 2005 starting point and red indicates erosion relative to the 2005 starting point.

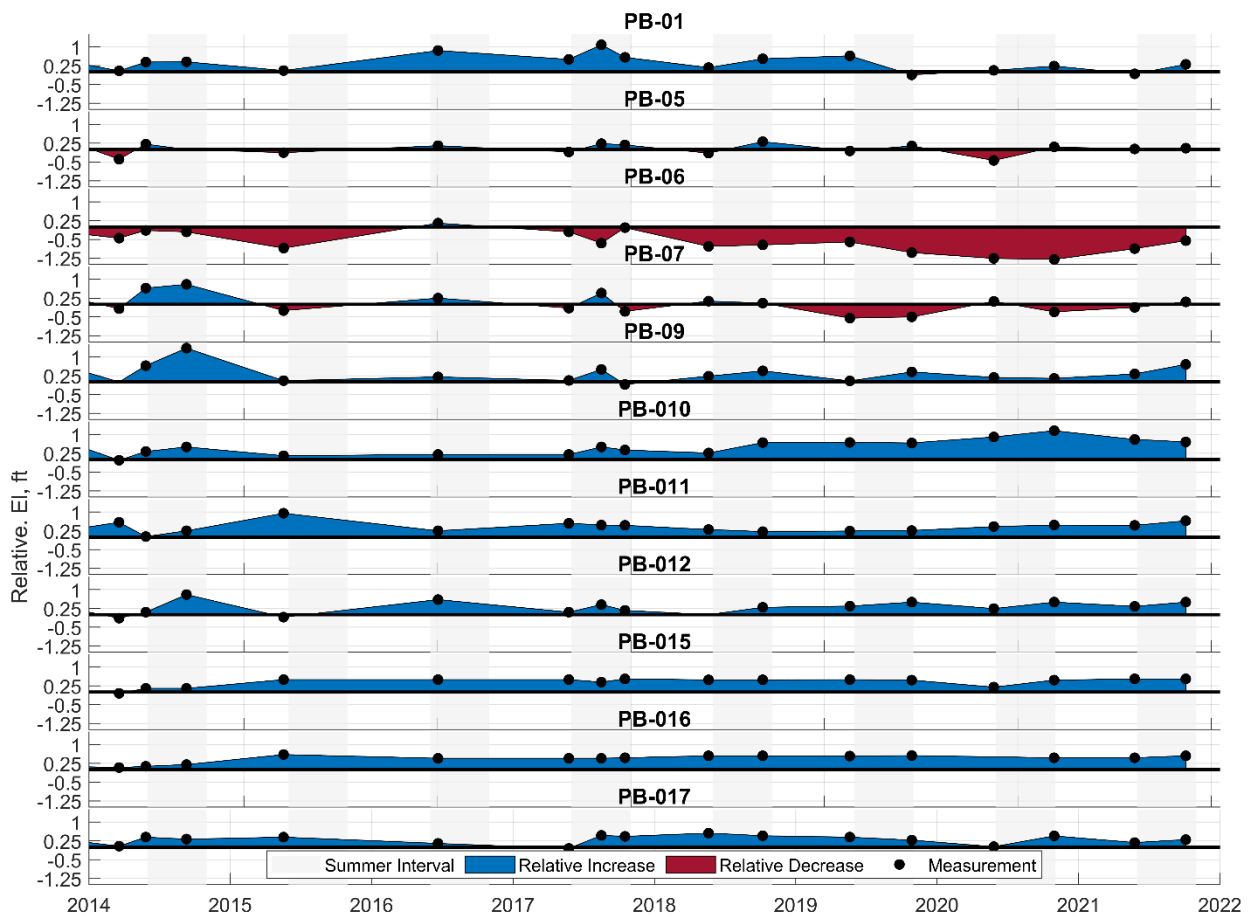
The beaches along Pleasant Beach are composed of mixed sand and gravel and exhibit seasonal variability ranging from +/- 0.25 ft to +/- 0.5 ft (Golder 2013). Figure 6 (see also Appendix A, Figures A-17 through A-35) shows time series of beach elevation from 2014 to 2021 (relative to the first survey in 2005) at all observation sites along Pleasant Beach and highlights the small variability at these sites over several years. The largest changes have occurred at PB_06, which increased 0.75 ft after reaching its lowest point since 2005 in 2020. At PB_09 the beach elevation increased 0.5 ft from 2020 to 2021, while at PB_10 the beach elevation decreased 0.5 ft from 2020 to 2021. Overall, 8 of 11 monitoring sites recorded beach elevation increases year-to-year from 2020 to 2021.

Figure 6. Time series of relative beach elevation from 2014 through 2021 at all beach photo survey sites along Pleasant Beach. Blue indicates accretion relative to the 2005 (not shown) starting point and red indicates erosion relative to the 2005 starting point.

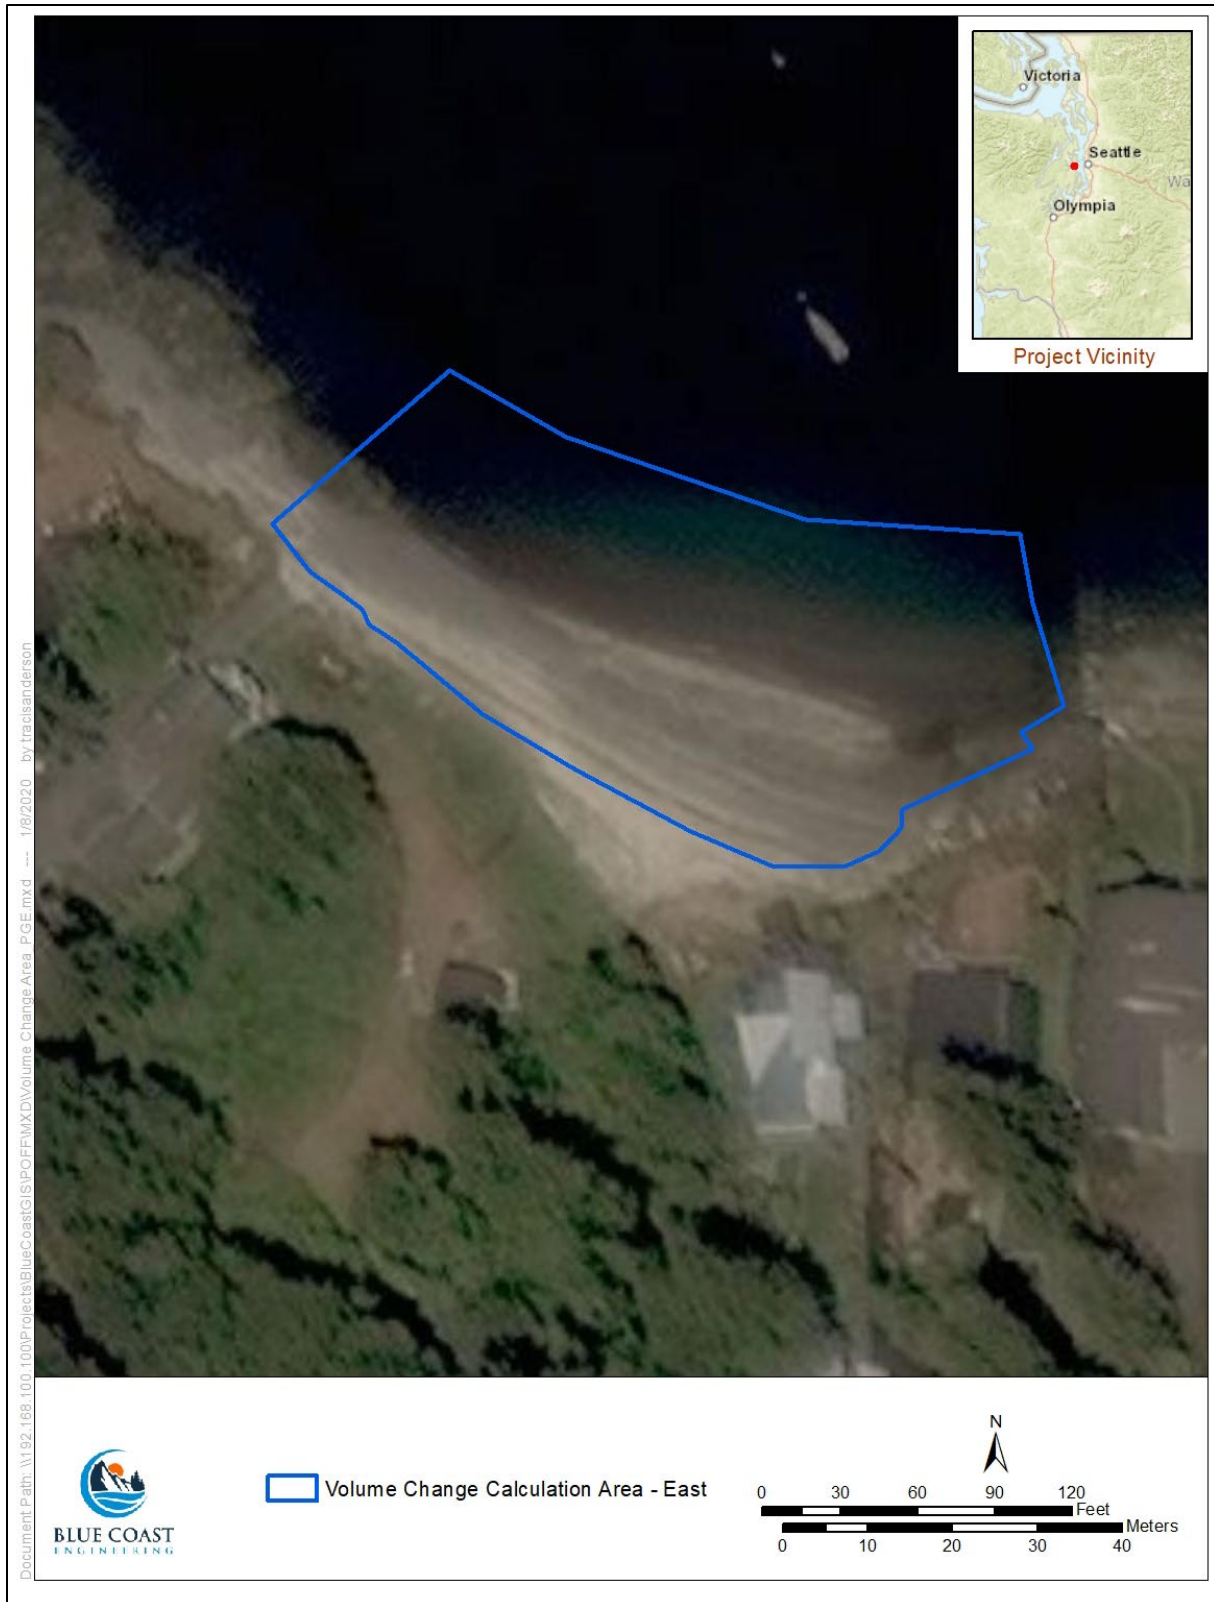
Figure 13. Area of Point Glover East where volume changes were calculated.

The magnitude and spatial extent of the erosion and accretion patterns along the east side of Point Glover vary extensively from year to year (Figures 11 and 12). To quantify and better understand the geomorphic patterns, Blue Coast conducted further analysis to calculate the total volumetric change within a subset of the survey area (Figure 13). The results of this analysis are shown in Figure 14; a positive number indicates net increase in volume within the calculation area and a negative number indicates net decrease in volume.

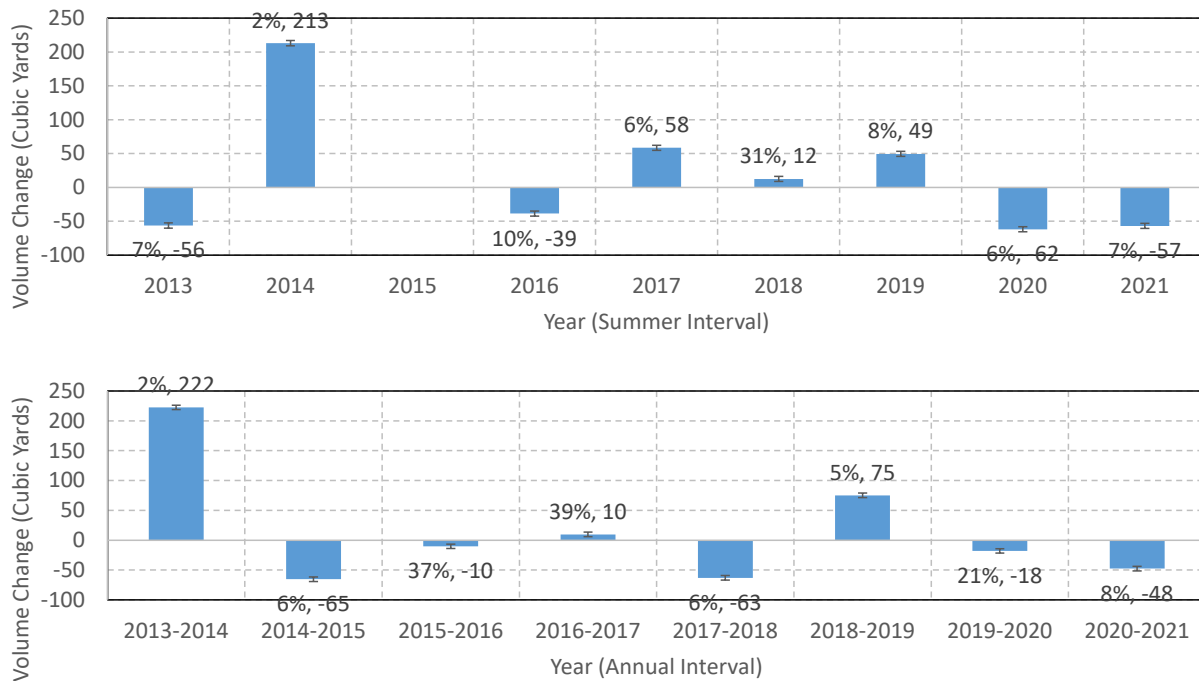
The total beach volume change between May and October 2021 (summer interval) was a net loss of 57 cubic yards (CY), compared to a net decrease of 62 CY during the summer interval in 2020. The volume change is consistent with the magnitude of volume decrease which occurred in 2013, 2016, and 2020. On an annual basis the volume change was a net loss of 48 CY which is a larger decrease than in 2020 but within the range of change during previous years (2014-2015 and 2017-2018).

Figure 14. Volume change (cubic yards) in calculation area at Point Glover East. The volume change and error as a percent of the total change are shown for each measurement.

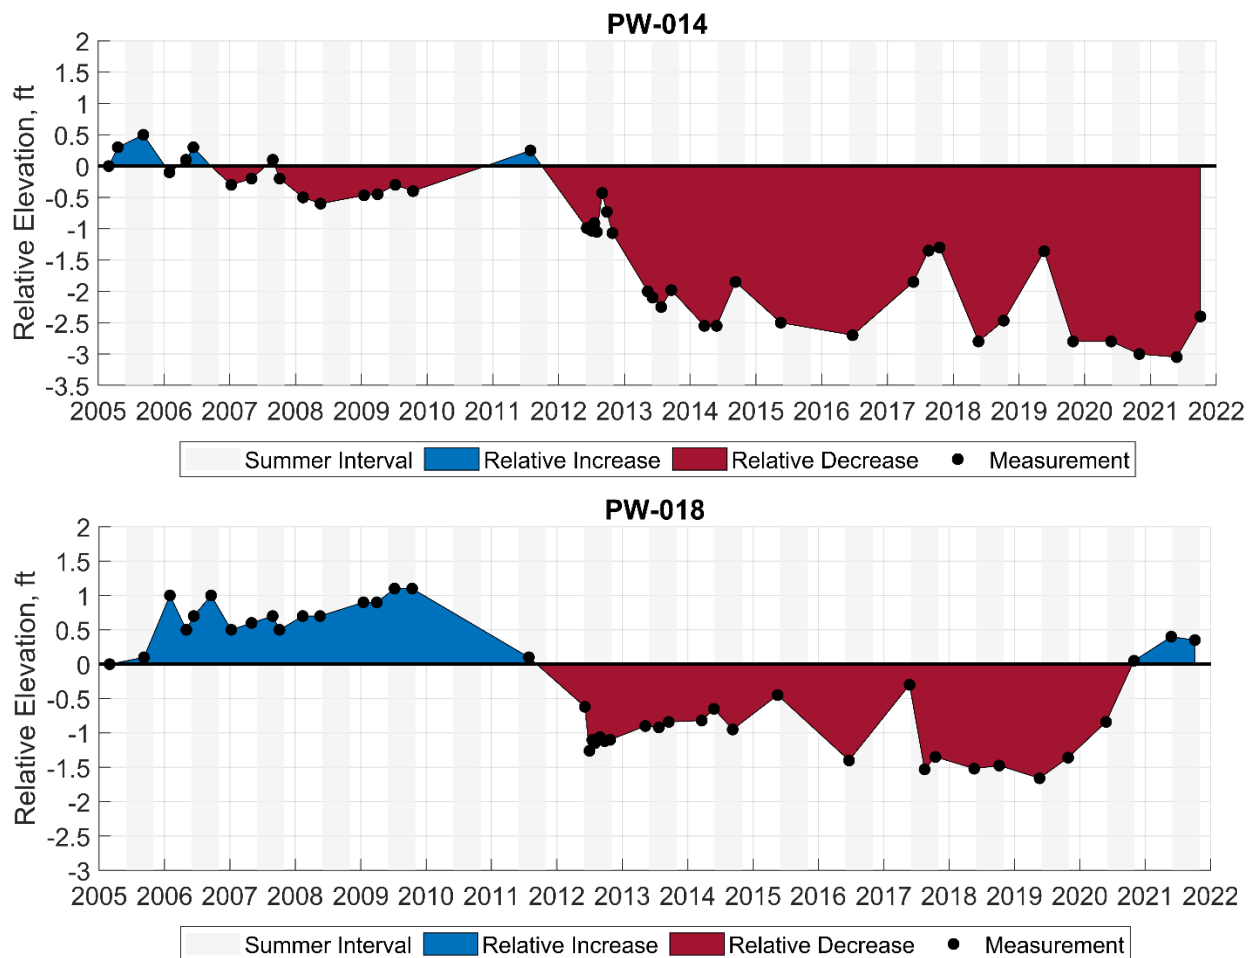
Despite the erosional trend at PW-05 and PW-06, occasional accretionary events are observed at these sites as is characteristic of other areas along Point White. Point White sites PW_07 through PW_18 (Figures A-57 through A-68) exhibit seasonal and annual fluctuations on the order of 1 ft. Waves of gravel move from the south to the north along Point White over an approximately 4-year cycle (Golder 2013) and result in localized highs and lows in beach elevation between sites PW_07 and PW_18 during different years. For example, beach elevation measurements at PW_14 have fluctuated over 1 ft from 2017 to 2019 (Figure 17). In 2020, there was minimal change to the elevation at the bulkhead. In 2021, the beach elevation at the bulkhead trended higher, with an increase over 0.5 ft from October 2020 to October 2021. At PW_18, the beach elevation continued the trend of increasing, with a change of over 0.25 ft from October 2020 to October 2021 and is now above the baseline level from 2005.

Figure 17. Time series of relative beach elevation from 2005 through 2021 at beach photo survey sites PW_14 and PW_18. Blue indicates accretion relative to the 2005 starting point and red indicates erosion relative to the 2005 starting point.

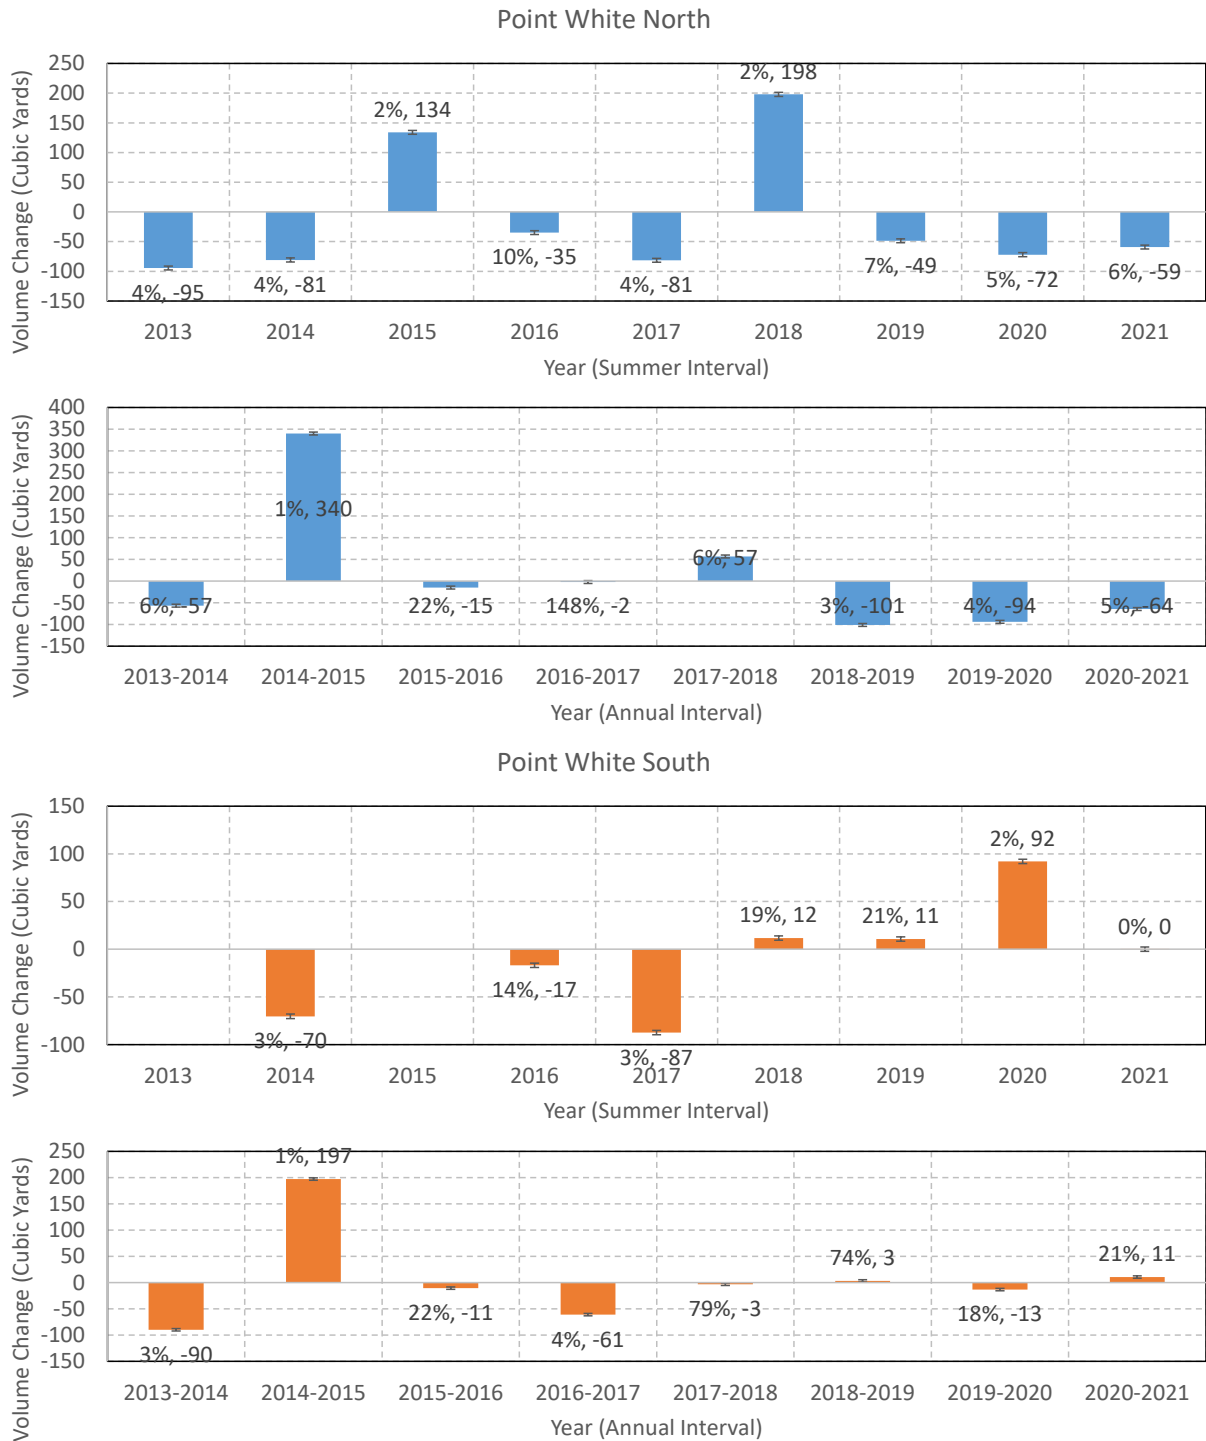
The total beach volume change between May and October 2021 was no net change at Point White South and a net decrease of 59 CY at the Point White North survey site. The beach changes are consistent with the previous measurements at the two sites. Volume change at Point White South are typically small due to the limited sediment supply near the start of the littoral cell. Point White North has measured similar net losses of sediment in 7 of 9 survey years since 2013 and due to it being within a transport zone in the shoreline littoral cell. On an annual interval there was a small net increase at Point White South of 11 CY and a net decrease at Point White North of 64 CY.

The volumetric change at both sites is consistent with the magnitude of change measured in previous years prior to RP1 operation. No differences in trends in beach response can be discerned from the volumetric change data.

Figure 4. Volume change (cubic yards) in calculation area at Point White South and North. The volume change and error as a percent of the total change are shown for each measurement.

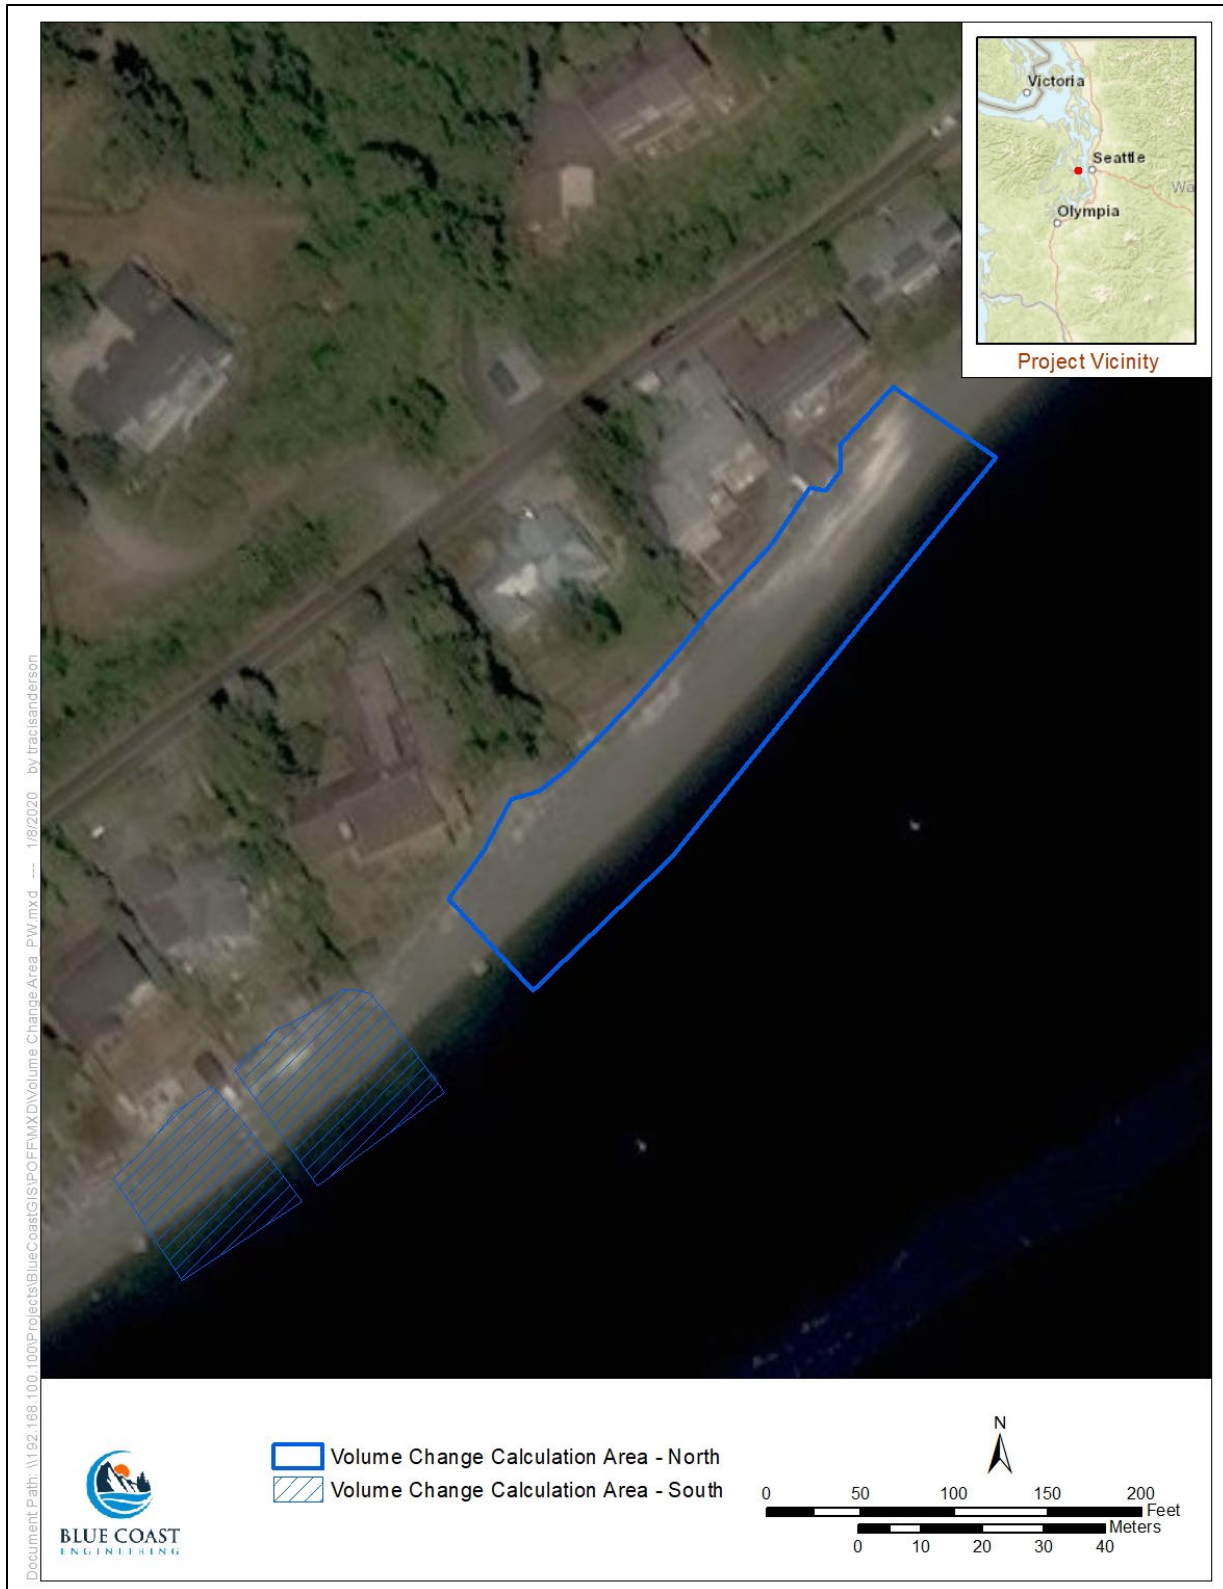
The magnitude and spatial extent of the erosion and accretion patterns along Point White vary from year to year, so further analysis was conducted to calculate the total volumetric change within two subsets of the survey area (Point White North and Point White South [Figure 21]). The results of this analysis are shown in Figure 20, where a positive number indicates net increase in volume within the calculation area and a negative number indicates net decrease in volume.

Figure 21. Calculation area for volume changes at Point White.
